# Forensic Engineering: The Investigation of The Causes of Asymmetry Trailing Edge Flap During The Aircraft Boeing 737 Landing.

#### Description Trailing edge flap system Boeing 737-300F

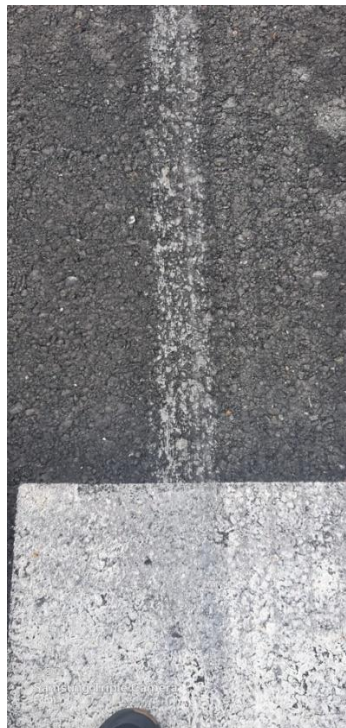
**Figure 2. The starting point of the scratch on the runway**

Initial data includes several aspects, namely, data on personnel on duty, aircraft data for the last six months, airport technical data. The data taken during the initial investigation was carried out after a serious aircraft incident by observing and collecting data in several conditions, including marking data on aircraft tracks found on the runway, and the condition of the airport and runway. In the data taken, there are scratch marks from the aircraft's paint on the left side of the runway which forms a white scratch line, and scratch marks on the tip of the left wing of the aircraft and the left engine of the aircraft on the runway which form a white scratch line. As can be seen in Figure 2, this could be the starting point for a streak of white paint that is not an official marking or airport runway marking.

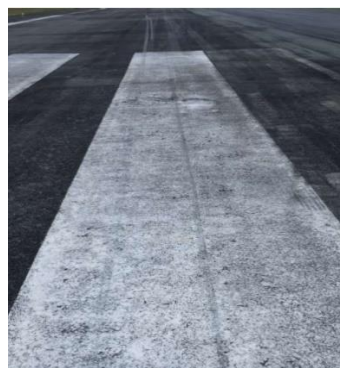
**Figure 3. White paint stripes towards the center of the Runway**

Referring to Figure 3, it should be noted that there is a visible scratch on the runway that extends towards the center, exactly parallel to the plane's landing direction.

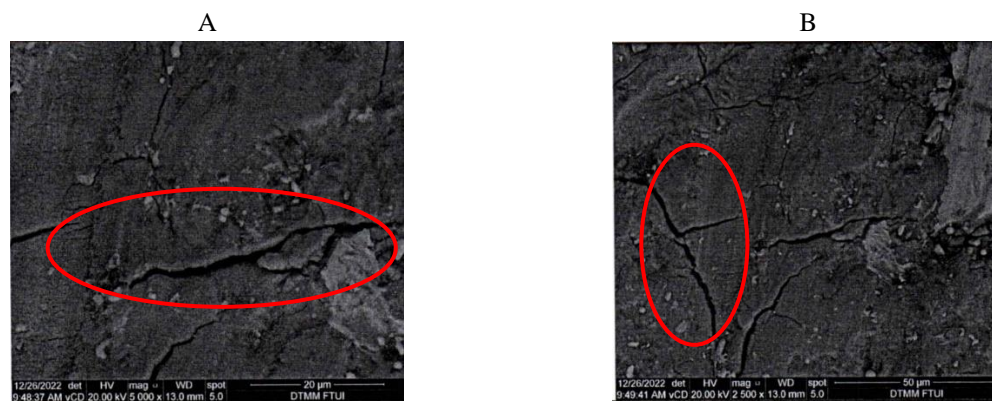
**Figure 6. FESEM test results. A). FESEM test results with 5000 times magnification. B). FESEM test results with 2500 times magnification.**

The results of the FESEM test performed on the component parts of the Ball screw or screw jack with part number 57022243670 are illustrated in the figures 6 and figure 7 presented above and below. These findings provide valuable insights into the quality and performance of the tested components.

1. The results of the FESEM test from ballscrew or screwjack samples that experienced corrosion were shown to have a high oxygen content value of more than 20%, which should have an oxygen content value of 0% as can be seen in the table 2.

2. The results of the FESEM test from ballscrew or screwjack samples can be seen in Figure 6B is a photo with a magnification of 500x (times) and the figure 7B is a photo with a magnification of 1000x (times), that the material is corroded and brittle on its surface, and oxidation occurs on its surface.

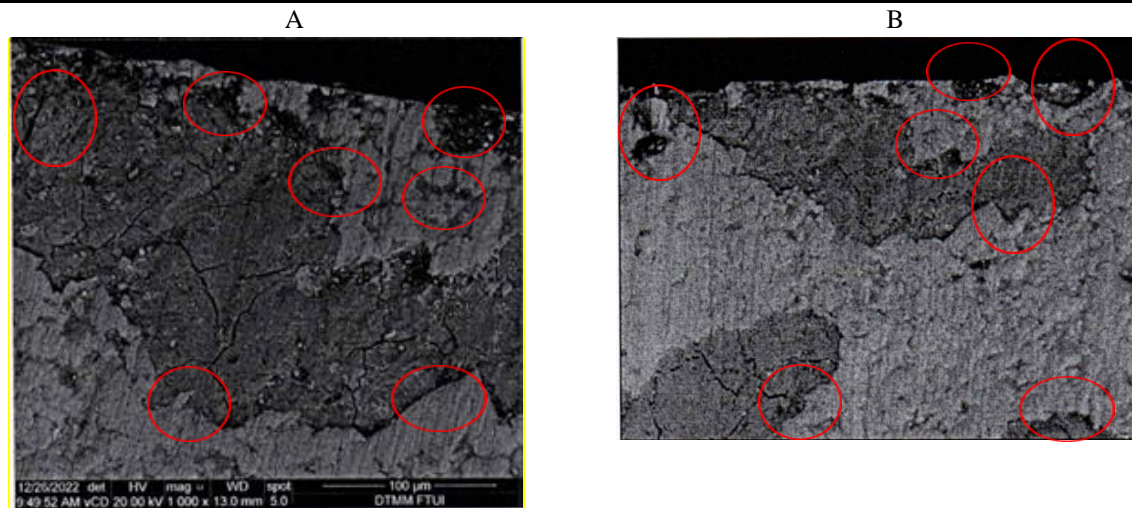
Figure 8. FESEM test results. A). FESEM test results with 1000 times magnification. B). FESEM test results 500 times magnification.

Based on the attached figure 8 on below which shows the results of the Field Emission Scanning Electron Microscope (FESEM) test carried out on the ball screw or screw jack component parts with part number 57022243670. Based on observations, it appears that this part is experiencing problems with corrosion and thread sharpness. In Figure 6, the results of the FESEM test are taken from other parts of the ballscrew or screwjack components which are the same as P/N: 57022243670 which are experiencing corrosion and thread sharpness. In figure 6A marked with a red circle oxidation occurs which causes corrosion on the ballscrew, is the result of the FESEM test with 1000x magnification, and the figure 8B, is the result of the FESEM test with 500x magnification.

Such information can prove instrumental in gaining a more comprehensive understanding of the nature and extent of the corrosion present, allowing us to make more informed decisions regarding the necessary repairs or maintenance.

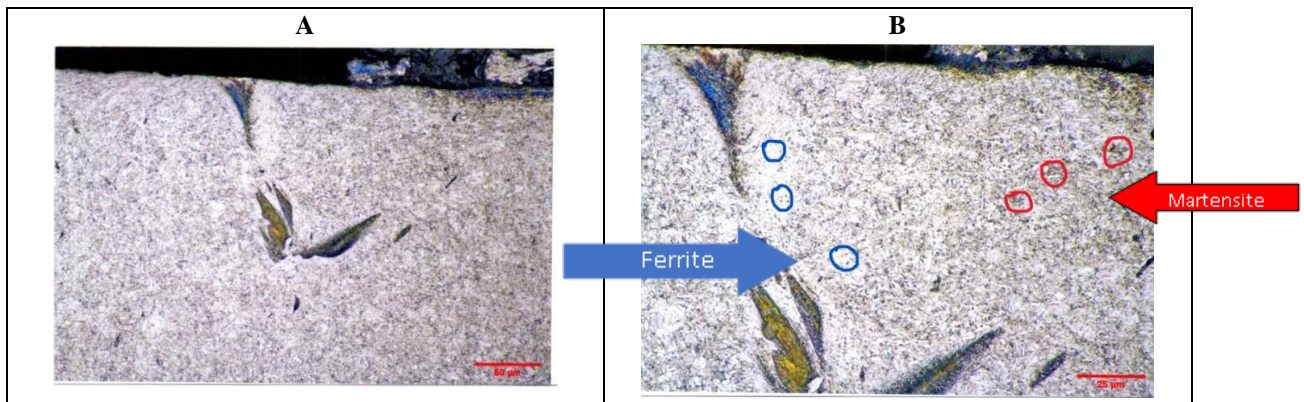
**Figure 10.** The microstructure Observation test method of the torque tube which is worn out condition, A) Figure A has been magnified by a factor of 500; B) Figure B has been magnified by a factor of 1000.

The image depicted in Figure B showcases a highly magnified view of the torque tube segment that has undergone material degradation. The microscopic details have been amplified by a factor of 1000, providing a comprehensive and detailed view of the affected area.

1. Shown from a photo in figure 10B is the 1000x microstructure component of the torque tube made of AISI 4340 steel, marked with a blue circle is the ferrite phase of the material, this crystalline structure gives the magnetic properties of steel and cast iron, and is a simple example of a ferromagnetic material. The mark circled in red is the martensite phase of the material, martensite is formed on very fast cooling from the austenite phase, so the diffusion process does not take place. Martensite is hard, strong, but brittle. Martensite is a microscopic structure formed when a metal or metal alloy is subjected to rapid heat treatment.

2. In the torque tube component, it can be seen that the microstructure of the ferrite and martensite phases is almost balanced or almost the same amount, only slightly more martensite phase microstructure, but not like the martensite composition found in gimbals. Therefore the hardness test results for the torque tube component material show a slightly higher hardness value than the ballscrew component material hardness value. Then when compared with the hardness value of the gimbal component material, the hardness value of the torque tube component material is lower.

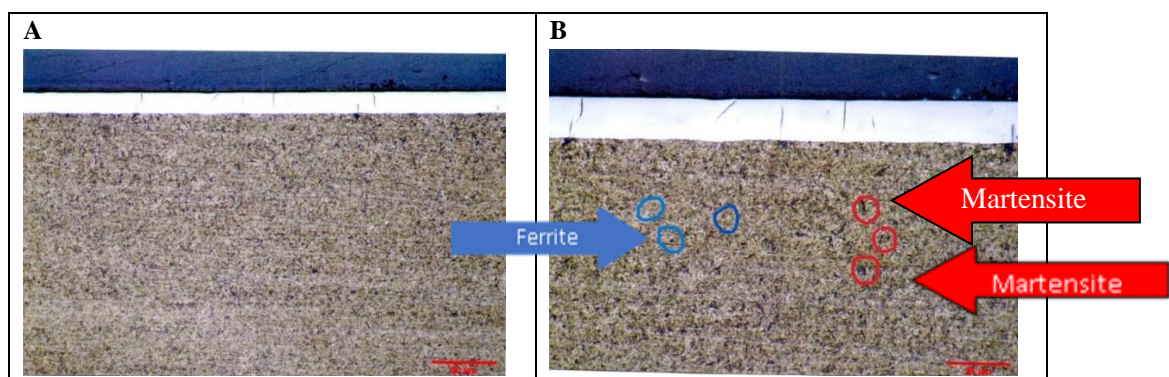
**Figure 11.** The microstructure Observation test method of the ballscrew or screw jack which is corrosion condition, A) Figure A has been magnified by a factor of 500; Figure B has been magnified by a factor of 1000.

Presented in Figure 11A is a microscopic photograph showcasing a ball screw or screw jack that has undergone corrosion, magnified to 500 times its original size. The image aptly captures the intricate details of the screw's surface, which is remarkably sharp and well-defined.

The accompanying image depicts a highly magnified view of a corroded screw jack. With a 1000x zoom, the image in Figure 5B provides a clear depiction of the screw's surface and its sharpness.

1. It is shown in figure 11B is the photo of the 1000x microstructure component of the ballscrew or screwjack made of AISI 4140 steel, marked with a blue circle is the ferrite phase of the material, and given a red circle is the martensite phase of the material.

2. There are more ferrite microstructures in the ballscrew, an allotrope of iron that is stable at high temperatures and pressures. The ferrite phase is called alpha iron ( $\alpha$ ) and is a solid interstitial solution with a crystal cell in the form of a BCC (Body Centered Cubic). The space between the atoms is small and tight so the solubility of carbon is very small. At room temperature the carbon content is only 0.008% so it can be considered pure iron. The maximum level of alpha iron is 0.02% at temperature A1 or 727°C. Ferrite is ferromagnetic up to 768°C and is ductile. In general, the ferrite phase is soft, ductile, and magnetic up to a certain temperature. The solubility of carbon in this phase is relatively smaller than the solubility of carbon in another solid solution phase in steel, namely the Austenite phase.

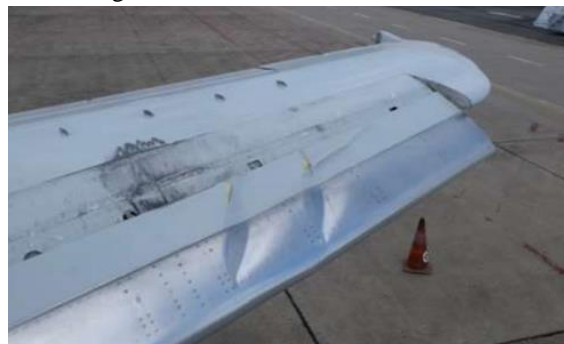
**Figure 12.** Photo of the upper surface of the left wing of the aircraft.

On the left wing, the upper surface of the left wing of the aircraft, the leading edge was found to have damage, dents and wrinkles, as can be seen in Figure 12.

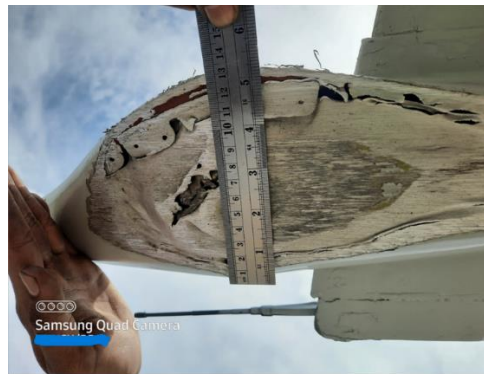
**Figure 13. The left-hand wing cover lamp logo**

The figure 13 is shown the damage found on the tip of the left wing of the plane, which rubs against the runway when the plane is about to land, is measured for the length of the damage.

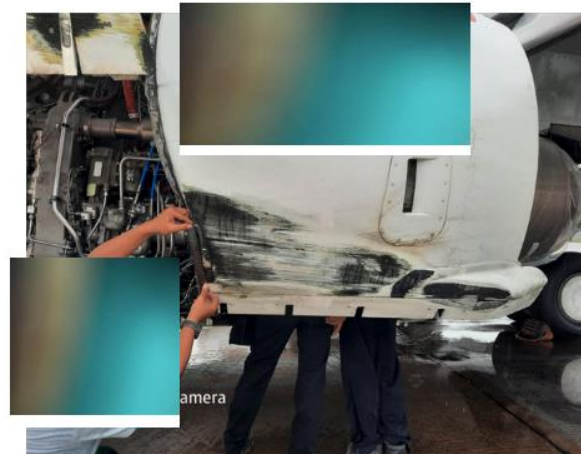
**Figure 14. The left-hand engine cowl.**

The data presented in Figure 14, indicates that the engine situated on the left side, alternatively known as engine 1 or L/H engine, has sustained damage to the left side of its fan cowl, specifically towards the rear.

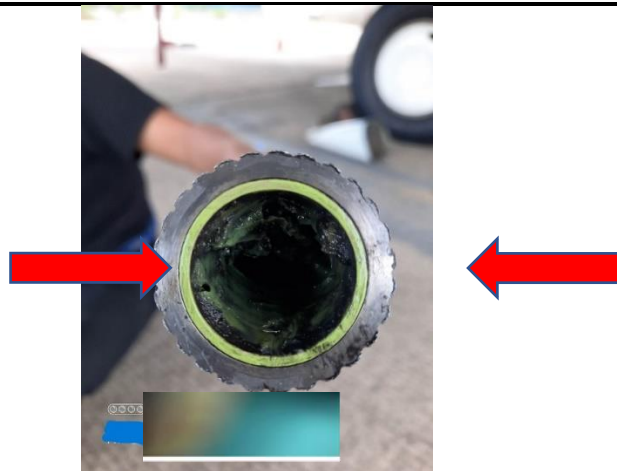
**Figure 15. The torque tube that has wear on all the gears**

12. Performed the inspections on all torque tubes, and after inspection, it was found that the torque tube on the left wing had wear on its teeth. The torque tube that experiences wear on all of its teeth is the torque tube that connects the flap power unit to the flap angle gearbox.

In the figure 15, it can be seen that the gear from the Torque tube, which is experiencing wear which is connected from the Flap drive unit to the flap angle gearbox, was found during the investigation and rectification of the aircraft at the scene.

5. Based on the results of research and investigations that were found to occur wear on all gear components of the torque tube due to material fatigue.

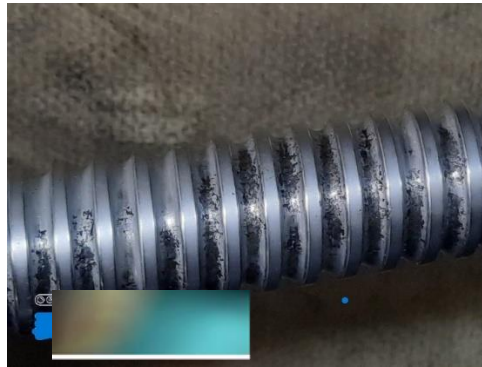
**Figure 16. The ball screw or screw jack corroded on its surface and sharply of threaded**

10. Performed a visual inspection of all the ballscrews, and after inspection, it was found that all four ballscrews which were found all of the ballscrew on the left wing of the aircraft had corrosion on their surfaces and there was sharpening of the threads on two of the ballscrews.

Upon inspection, the screw jack or ball screw displayed signs of corrosion in multiple areas. Furthermore, the picture reveals that the threads of the screw jack have lost their sharpness please see in the figure 16.

4. Based on the results of research and investigations, that was found to have occurred thread sharpening and corrosion on the ballscrew surface due to contact between metal and metal, namely, there is contact between the ballscrew and the bearing on gimbals without lubrication.

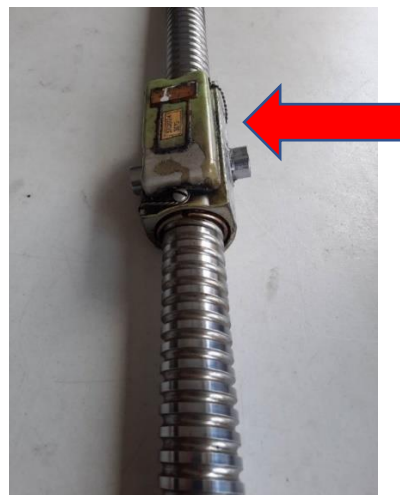
**Figure 17. The gimbal nut before testing.**

11. Performed the inspection on eight gimbal assy, and after inspection, it was found that all gimbal assemblies on the left wing of the aircraft (four gimbal assy.) were dry without any lubricating oil (fluid 4) which is used to lubricate the ballscrew when the trailing edge flap moves.

After conducting a thorough examination of the gimbal component, we have found that the section housing the screw jack/ball screw with pointed threads is devoid of any lubrication, which is clearly visible in the attached picture is shown in the figure 17.

3. Based on the results of research and investigations, that was found to have occurred the problem with the assembly gimbal component is that there is no lubricating oil (fluid 4) to lubricate the ballscrew, or dryness occurs on the deadlocks.

Based on an extensive analysis and the experience of a reputable airline equipped with a state-of-the-art data recording system, it is advisable to establish a life limit threshold for the gimbal's component. This measure will effectively safeguard and preventive the ball screw and torque tube from any potential damage. Replacement of the component is recommended after a specific number of usage hours, ideally ranging between 22773 flight hours and 23156 flight hours.
