ISSN: 1001-4055 Vol. 44 No. 4 (2023)

Masonry Shear Triplets Coated with Fiber Reinforced Mortars

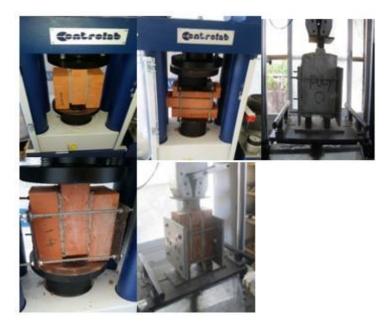
Fig.2: Test setup of shear triplet test

2.2. Shear Triplet Tests Setup and Procedure

One type of mortar was used in the construction of the specimens having mix ratio of 1:1:5 of (Portland cement: hydrated lime: sand). In the reinforced plaster mortar, 2% of polypropylene is added to the mortar. Three specimens were tested at each level of pre-compression stress; with each specimen consisting of three 210 mm × 105 mm × 55 mm perforated bricks bonded by 10mm thick mortar joints. To assess the initial strength and friction angle of the unit–mortar interface, four levels of normal compressive stress (0, 0.2, 0.6, and 1.0 MPa) were used in accordance with BS EN1052-3[13]. A vertical load-controlled cylinder has a force capacity of 100 kN and a loading rate of 1.5 mm/min. was applied perpendicularly to the triplet specimens to investigate the failure behavior of the two mortar joints under shear stress. Each specimen was centered in a vertical position in a hydraulic compression testing machine and then a shearing load was gradually applied (see Fig.2). Triplet shear tests were conducted on perforated brick blocks with and without retrofitting. To provide the stability of the test setup, the outer two bricks were also supported by two steel profiles. The test setup was fabricated to accommodate different pre-compressive levels of normal stress for shear triplet specimens; it consists of top and bottom steel plates connected by bolts at each end. A pre-compressive normal stress was applied and it remained constant throughout the test.

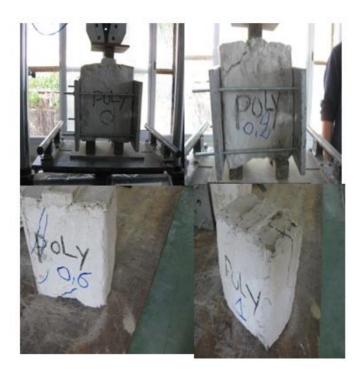
The reinforced shear triplet was subjected to the same pure shear loading. Figure 8 shows the final states of failure of reinforced specimens (RST) under different values of pre-compression, the result shows that the failure modes of all plastered specimens were similar due to a diagonal or vertical crack in the direction of loading, which followed the interface between the bricks and joint mortar. Through the application of reinforced plaster, the samples were able to deform more easily and were covered by not leaving the samples after the experiment. As a result, rupture of the samples was prevented and ductile behavior was achieved. Fig.9 represent the behavior of stress-strain for reinforced shear triplets under four levels of pre-compression applied initially. From this figure, it is noticed that maximum stress increases with increasing of compressive normal stress.

Fig.8: Final states of failure for triplet shear tests under different value of pre-compression for reinforced sheartriplets (RST)
