Development Fitness-for-Service Application Program with Case Study on Equipment Used in Oil and Gas Sector

Aswin Lorenzo Gultom ^{1*}, Andi Rustandi ²

^{1,2} Department of Metallurgical Engineering and Materials, Faculty of Engineering, Universitas Indonesia, Depok, 16424, Indonesia

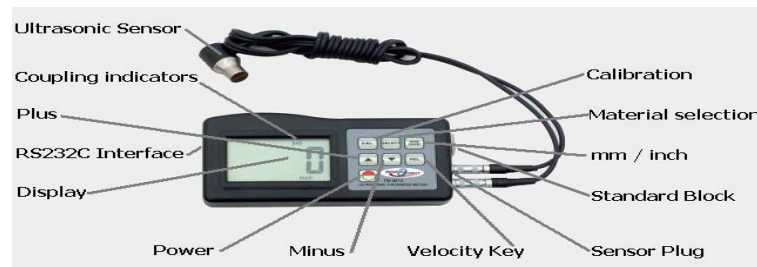
This tool serves to measure the actual thickness of the plate on the tank wall by utilizing ultrasonic waves, but this tool can only be used when the tank condition is not operating (offstream). To take measurements used sensors. This equipment was developed for permanent installations such as pipes and vessels. This equipment can work at temperatures up to 120 °C and has 1 (one) sensor attached directly to the plate. To reach the top tank wall, of course, tools such as ladders, staggers and rafling equipment are needed.

Figure 1. Ultrasonic Thickness Meter

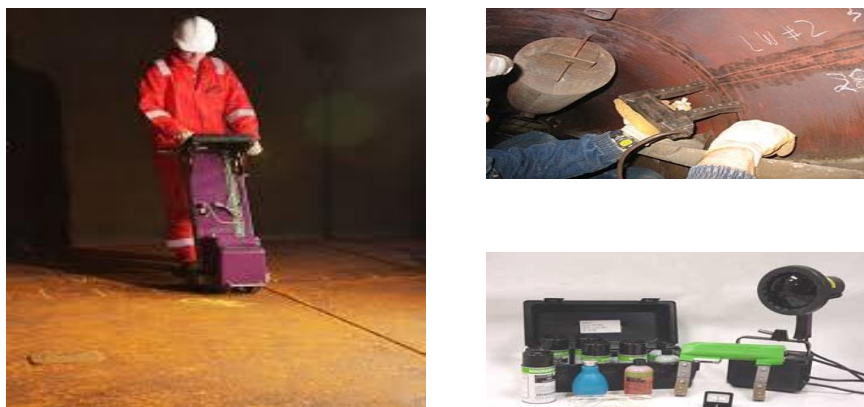
MFL floor scanner serves to measure the thickness of the plate on the tank floor by utilizing a strong magnetic field while the magnetic yoke is usually to see if there is a defect in the tank wall weld. MFL floor scanner is very suitable for measuring the thickness of the bottom plate because several plates on the tank floor are overlapped. This tool is also used when the condition of the tank is offstream.

Figure 2. Magnetic flux leakage and yoke

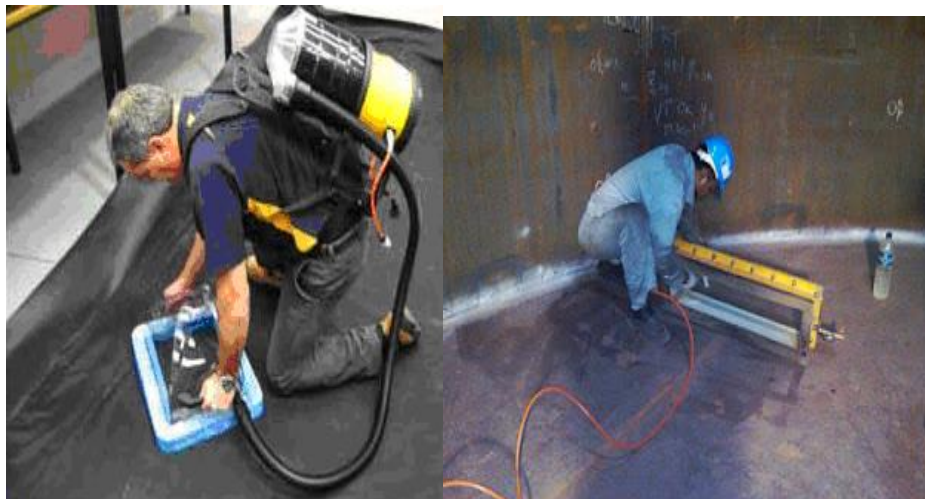
Vacuum Box Testing is used if there is an area on the tank floor that is indicated to have a leak. This tool works by applying suction pressure (0-15 psi) on the tank floor and on the other hand given fluid / foam and then held at a certain grace period (10-30 seconds) to ensure foam does not propagate to other surfaces. To detect fine leaks, you can also use a vacuum box with a larger pressure, which is 21 – 35 KPa.

Figure 4. Vacuum Box Testing

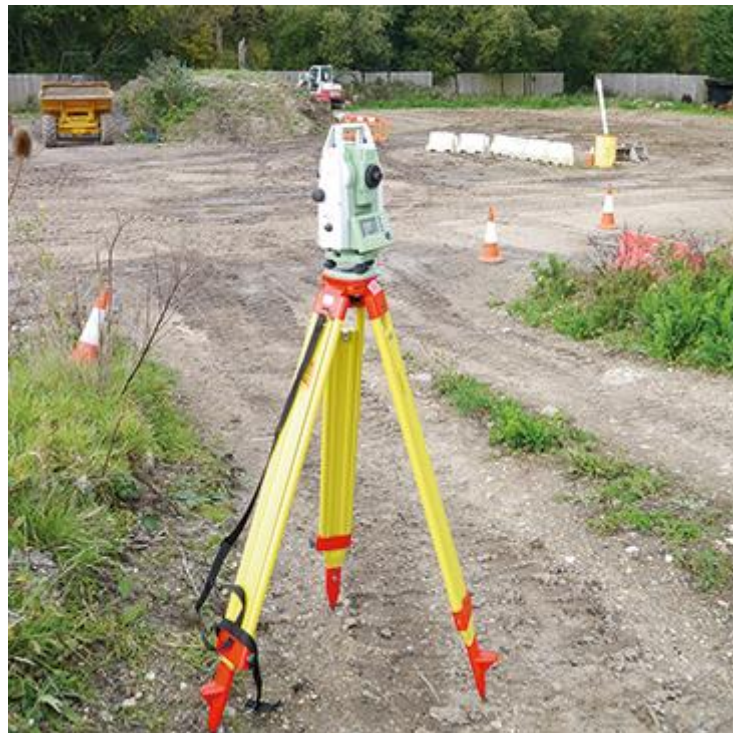
This tool is used to measure the slope and roundness of the tank roof. To measure slope, a benchmark point is needed as a reference. The maximum allowable slope of the tank is $1/200.H$.

Figure 5. Theodolit

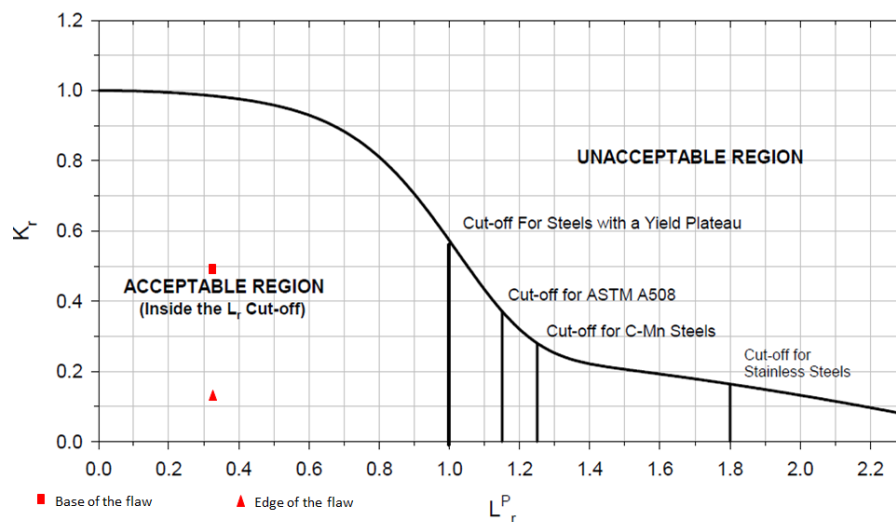
1. Determine the maximum depth and maximum length of crack that can be analyzed with level 1 and level 2. Based on the calculations in annex L.4.2 it can be seen that the maximum depth is 4.5 mm and the maximum length is 4.2 inches. Then the crack that occurs can still be analyzed with level 1 and level 2.
2. Create a failure analysis diagram:

Figure 7. FAD results for LPG drums (D-6408)

After mapping the plastic interaction factors, L_r^P and the power ratio, K_r turns out CLF is still in the safe zone so that the tank can be reused. In addition to conducting CLF analysis, it is also necessary to analyze the corrosion evenly and the residual age based on corrosion rate. Because the diameter of the tank is smaller than the length of the tank, corrosion analysis must use a critical thickness profile. Here is the FFS process performed:

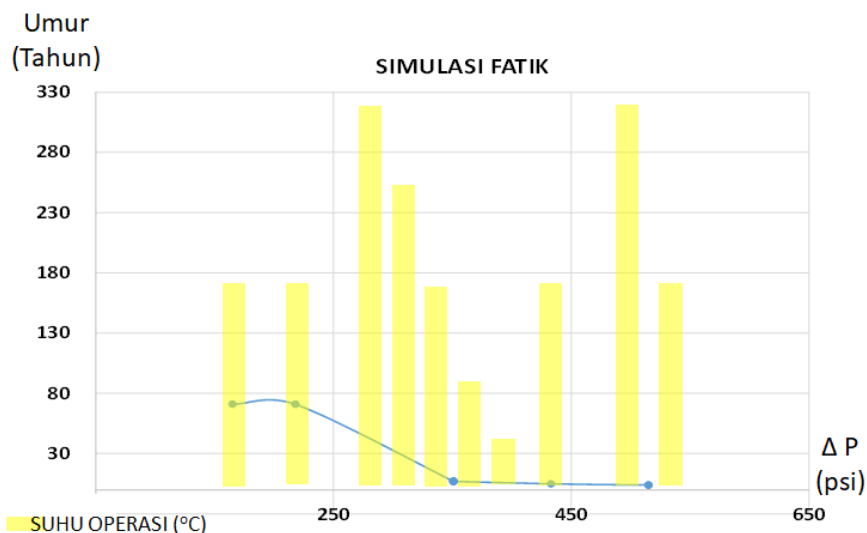
Figure 10. The simulated life of the mixing container is simulated at various changes in pressure (psi) and temperature (°C).

Based on the graph above, it can be concluded that the difference in temperature and pressure will affect the life of the tool, but the most dominant in affecting the life of the tool is pressure.
