# Impacts of Vibrations in Olive Oil Presses Components

**Abstract.** Vibrations have bad effects on machines and systems if they are repeated and occurred frequently with a frequency close to the natural frequency of that machine or component. Any machine having rotating parts, will have vibrations, oil presses have a sequence machine, which have rotating parts and oscillators. Such vibrations have different frequencies which may reach to some values closes to the natural frequency of the components which may effect on the performance of the stations' machine and then on the production line or cycle and hence on quality of olive oil produced. In this study, the sources of vibrations in such olive oil presses will be investigated, measured, and analyzed and a mechanical solution will be proposed to reduce such vibrations and hence improving such presses performance and increase production of oil and its quality. A SIMIO model is implemented in the study to show the effects of vibrations on productivity of a given press (mill) olive oil after adjusted to overcome the vibration effects. The main sources of vibration in rotating machines are misalignment, imbalance and bearings wear,

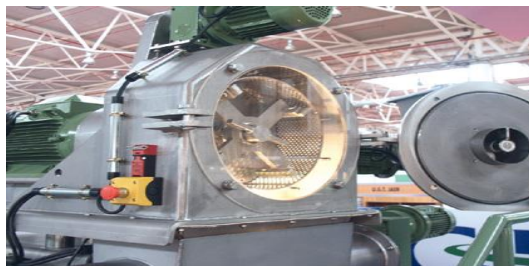
Fig.1.A Single olive mill [1]

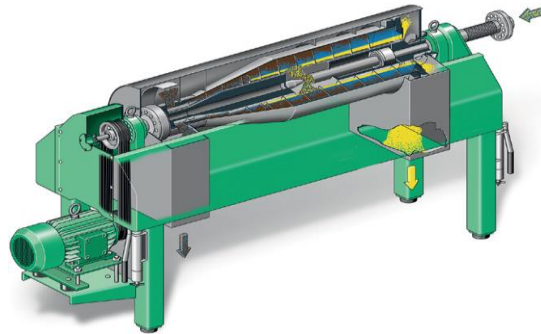
**Fig. 2. Separator machine [1]**

The second process is to separate oil from olive oil pasta using Separators machine as shown in Fig. 2.

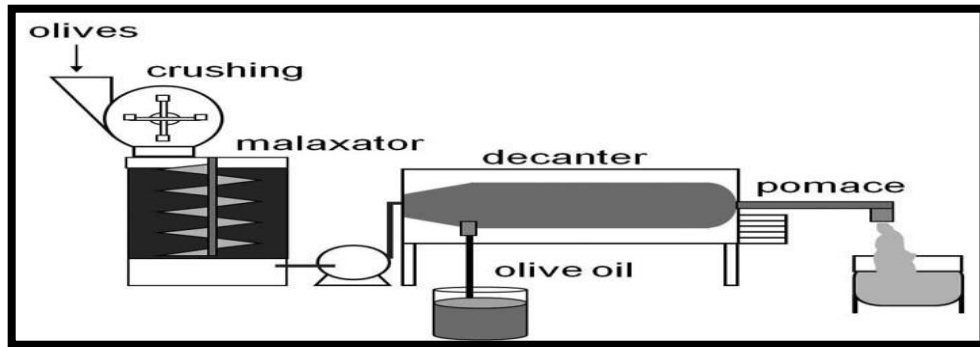
**Fig.3.The continuous low-scale plan used for olive oil extraction [2]**

The effect of vibrations on mechanical machines (like mills and separators of olive pasta) operating on flaws in the manufacturing process reduces the life of the devices and, over time, increases the stress, which leads to equipment failure and, in some cases, human injury. Fig. 3 shows the continuous low-scale plan used for olive oil extraction stages.

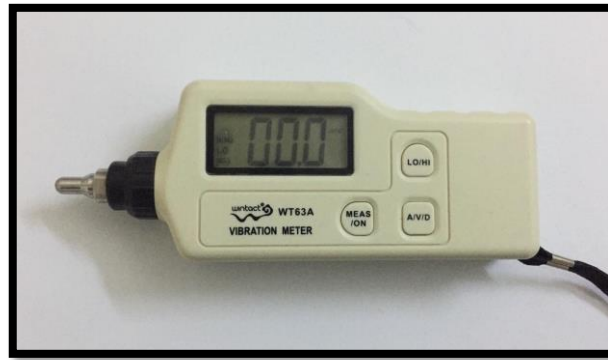
Fig. 6. Wt63a vibration meter was used in the study.

The study is executed experimentally at some selected olive press stations. To measure the values of vibration using a wt63a high quality portable vibration meter in different locations in the olive press. The vibration meter is used to measure variable data of vibration such as velocity, acceleration, and displacement, the vibration meter shown in Fig. 6.

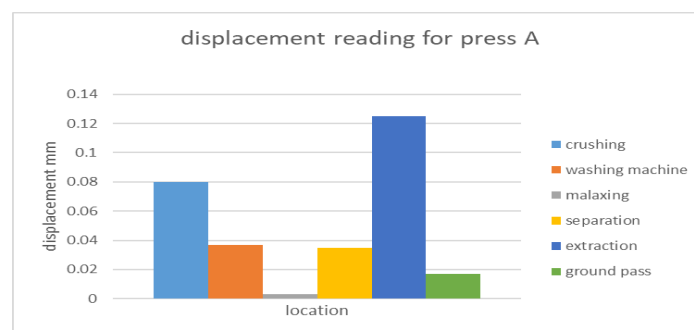
Fig. 8. The displacement readings for press A at 8/11/2022.

Table 2 shows the vibration parameters readings for press A on 8/11/2022 while Figures 8, 9 and 10 show such vibrations of this press. The data measured for press A showed that crushing and extraction components have high vibration velocity values and depending on ISO chart shown in Fig. 7, such components may be exposed to damage status, while other components are in safe status.

Fig. 9, 10 and 11 show the displacement, velocity and acceleration of the components of press A, it can be noticed that the crushing and extraction components have maximum displacement, velocity and acceleration values, which means that such component need to be maintained or adjusted to decrease such values by making alignment or balancing or replacing the assisted bearings.

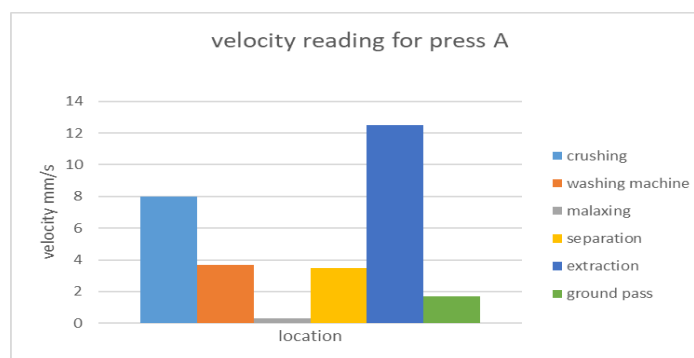
Fig. 9. Velocity readings for press A at 8/11/2022.

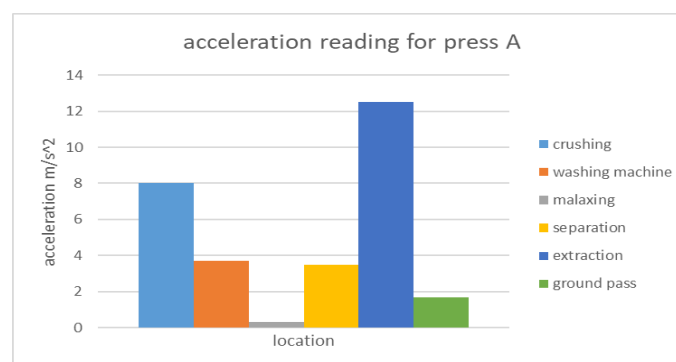
Fig.10. Acceleration reading for press A on 8/11/2022.

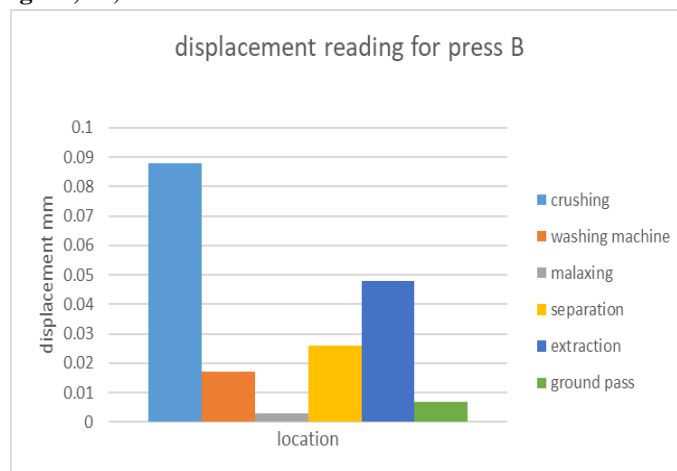
**Fig.11.** The displacement readings for press B at 8/11/2022.

Table 6 shows the vibration parameter readings for press B on 8/11/2022. It can be noticed that all components of press B are in good status depending on ISO standards except the extraction and crushing parts which have velocities of 8.8 mm/sec and 4.8 mm/s respectively which need to be fixed.

Fig. 11, 12, and 13 show such vibration values as bar chart.

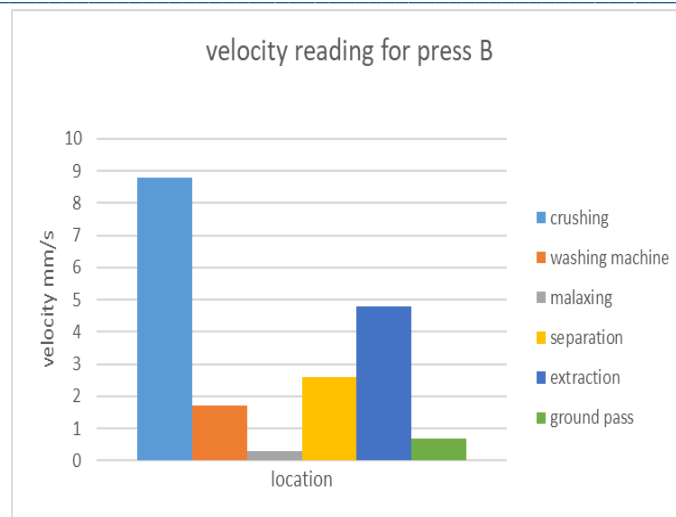
**Fig.12.** Velocity readings for press B at 8/11/2022.

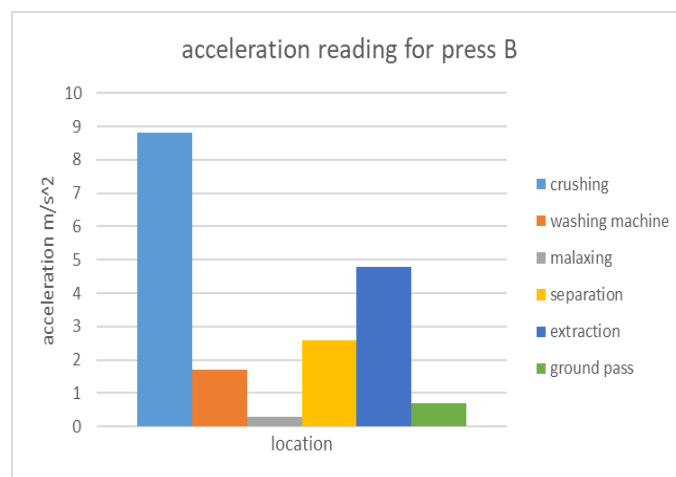
**Fig.13.** Acceleration reading for press B at 8/11/2022

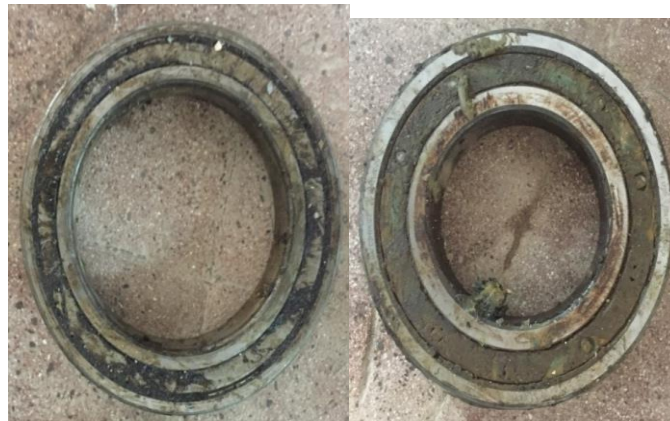
**Fig.17. Examined bearing**

In the first stage of the process of reduction the vibrations of the press, the rate of vibrations in the press was measured and the following values were (acceleration 12.5 m/s<sup>2</sup>, Velocity 12.5 mm/s, Displacement 0.125 mm). After studying and verifying the reasons that led to the presence of vibrations, there was a weakness in the quantity of production and the wear of a large number of pieces and the appearance of a loud sound from the machines. On the place of the production line and study the building plan, which in the first stage shows that the production line was part of it, such as the piston over an empty warehouse large area. After that, all parts of the production line were unscrewed and inspected from all the moving parts in the production line. It was found that there was wear in the endurance and the springs were examined bearing and was found by wear and rust because of the entry of water to some parts and exposed to excess heat led to the lubricant out of tolerance. (Fig. 17).

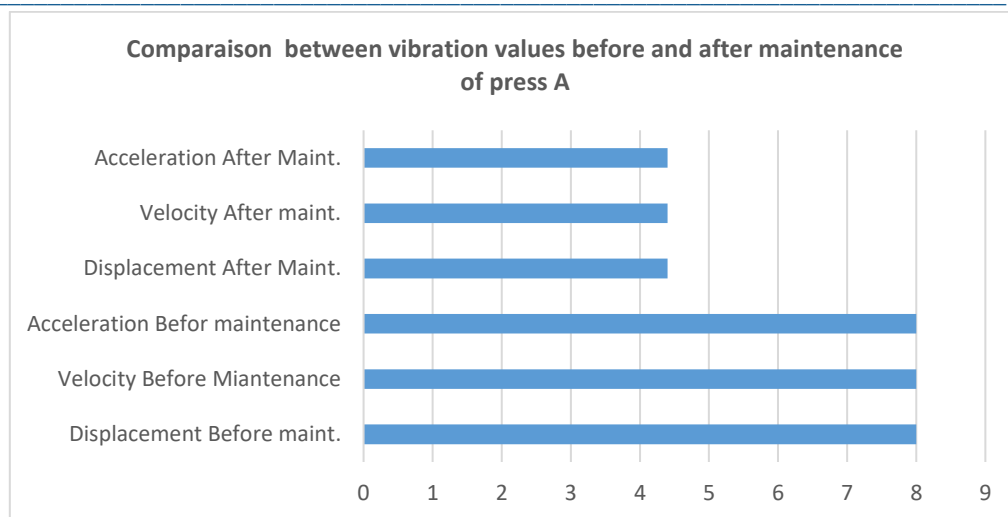
Fig.18. Comparing of vibration values before and after maintenance operations on press A.

The crushing readings in press A were high (about 8 mm for displacement, 8.0 mm/s for velocity, and 8 m/s<sup>2</sup> for acceleration) because it was found that the bearing in the pump suffering of mechanical wear and friction. The bearing was changed and the pump was rechecked then the crushing section had the following readings: (acceleration 4.4 m/s<sup>2</sup>, Velocity 4.4 mm/s, Displacement 0.044 mm) and the maintenance cost equals (300\$). Fig. 18 shows a comparison of such values before and after maintenance of the crushing element of press A.

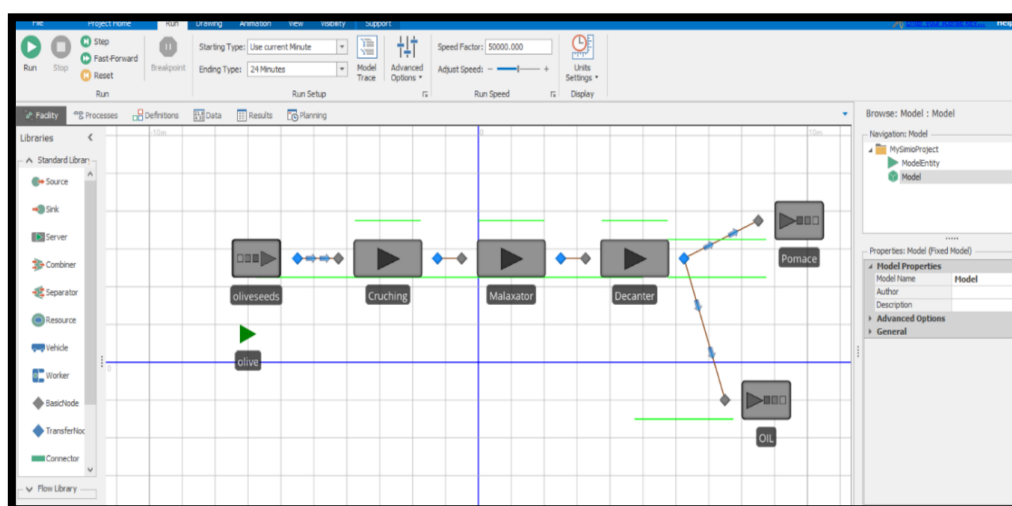
Fig.19. SIMIO model of press A

To prove the effectiveness of the decreasing of the vibration values on olive oil production, one press is simulated using SIMIO software, Fig. 19 shows the simulation of olive oil extraction plant-Press A. Fig. 20 shows the model while running.

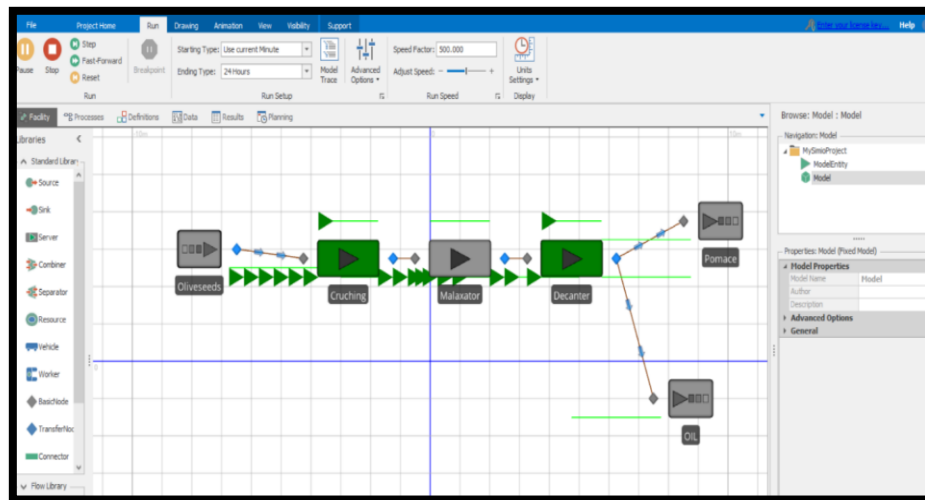
Fig. 20. Running the SIMIO model

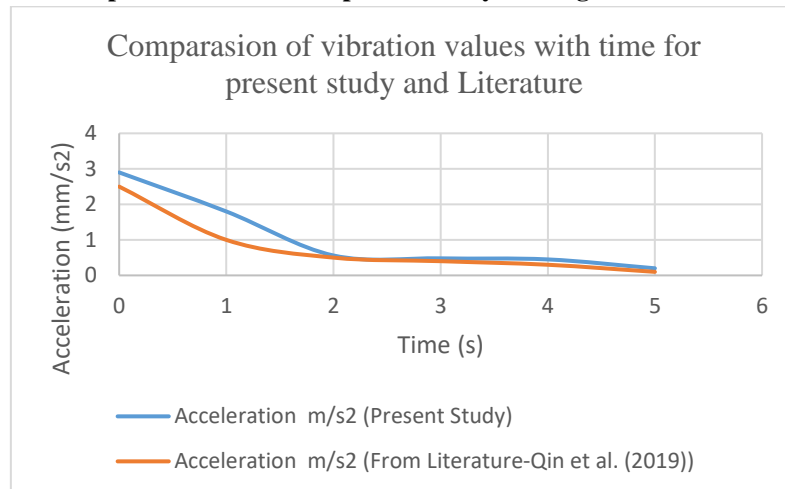
Fig. 21. Comparison between the present study reading and values determined by [7]

Fig. 21 shows a comparison between the present study reading and values determined by [7]

From Fig. 21, and by comparing values of acceleration for the same conditions of a rotating machine (crushing machine in the present study and propulsion shafting system by [7] a good agreement between the results can be noticed.
