# Forensic Engineering: The Investigation of The Causes of Asymmetry Trailing Edge Flap During The Aircraft Boeing 737 Landing.

#### Description Trailing edge flap system Boeing 737-300F

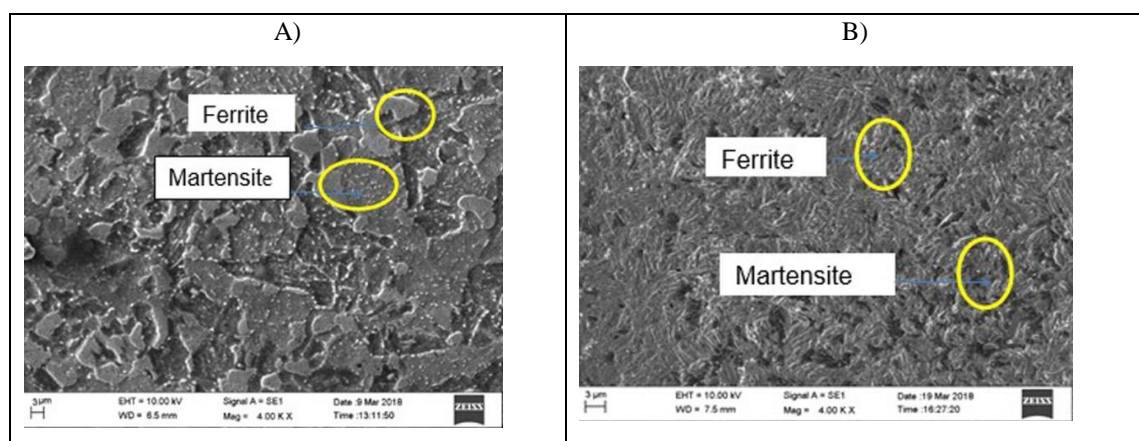
The metallographic test was carried out using the Microstructure Observation test method, using the Inverted Metallurgical Microscope testing machine, Olympus BX41M – LED. The tests were taken for the components, were: screw jack or ball screw with P/N: 57022243670, on the torque tube, was a failure that worn on the gears, and gimbal components are fused to the screw jack, which has thread sharpening

**Figure 9.** Ferrite-martensite structural phase in AISI 4140. A) Ferrite-martensite structural phase in AISI 4140 steel at 770°C. B) Ferrite-martensite structural phase in AISI 4140 steel at a temperature of 790°C. [Ref 17]
